Irwin Farmstead

Santa Rosa, California

HISTORIC RESOURCE ASSESSMENT

October 2003

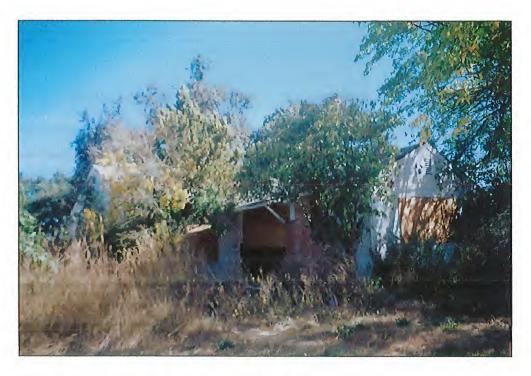
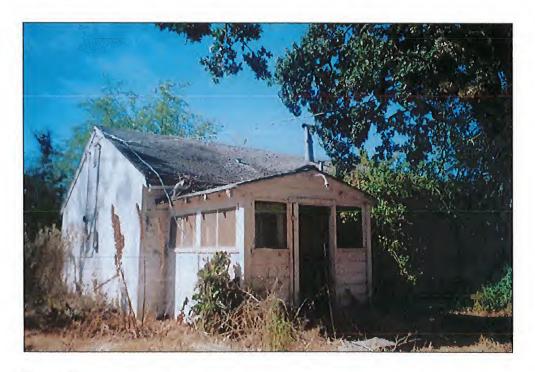
Figure 11: Views of 1951 house

The newer house on the site was built in 1951, according to Assessor records. It is an L-shaped, one-story, wood frame house with gable roofs and an attached, covered carport on the east side. The 'square' footprint of the house is roughly 30' by 30'. A covered entry and patio area is located on the west side of the house. The front portion of the structure was added in 1960, according to Martha Lawson (interview, October 2003). Several other additions and alterations to the structure exist, undermining its architectural integrity. It was reportedly damaged in the 1969 earthquake (Assessor Records, 1973).

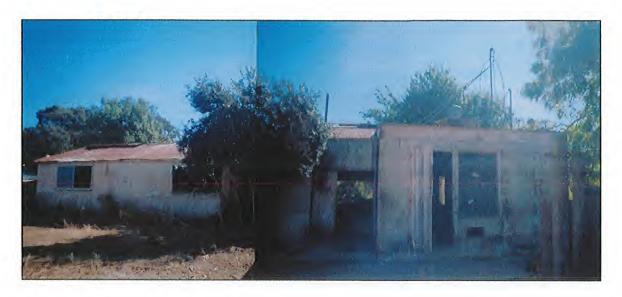
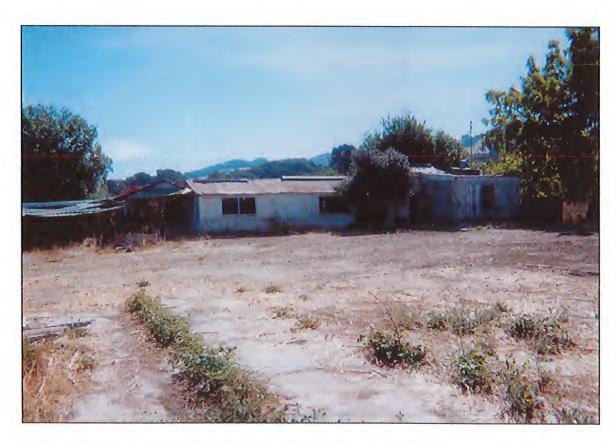
Figure 12: Two views of milking parlor

The Milking Parlor has been added to over time (essentially, what were separate buildings were connected with additions and a covered breezeway). Some portions of the structure are in poor condition, but the interior retains the features that indicate how the structure was used. Cows entered the north end of the structure, which is a series of sheds clad in metal and other various materials today. The central portion contains the milking parlor, which features a wood stanchion in the center along the length of the building, a molded-concrete feed trough along one side, to the west, and the milking area along the other side, to the east. The structure has a concrete slab floor and formed concrete walls. To the south is a concrete milk processing room. A narrow hall with concrete stairs (function unknown) separates the two. Pipes and meters in this hallway show how milk was piped from the milking area to the processing room.

Other interior rooms exist in this barn complex, and it is not clear what they were used for. Overall, the structure is in poor condition. The main function of the barn as a milking parlor, however, is still apparent.

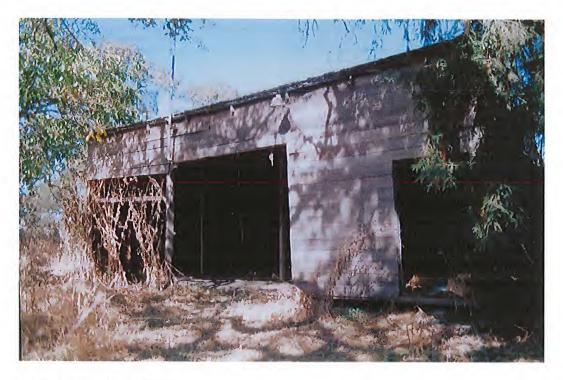
Figure 13: Views of machine shed

This structure is rectangular in shape, oriented east-west on the site. It features a shed roof, wood-frame construction and wood siding. It is in fair condition.

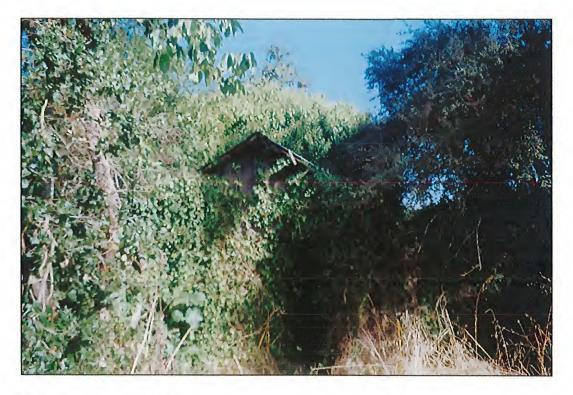
The chicken coop is a small structure to the north of the house, and may be a part of the original farmstead. It is a small, gable-roofed structure, its door facing south, towards the 1898 house. The chicken coop is made up of sawn vertical Redwood boards, about one-and-one-half feet wide and approximately three-quarters of an inch thick. There is no wood framing. Small rafters, narrowly placed, extend from the plate at the top of the walls to the roof ridge. Above this can be seen the original shingles. A corrugated aluminum roof now covers the wood shingle roof. It is in good condition, despite being grown over with vegetation.

Entrance to chicken shed
